## ASCE 10th Forensic Engineering Congress

### Unraveling Project Pitfalls: A Forensic Exploration of Communication, Coordination, and Collaboration Breakdowns in Construction

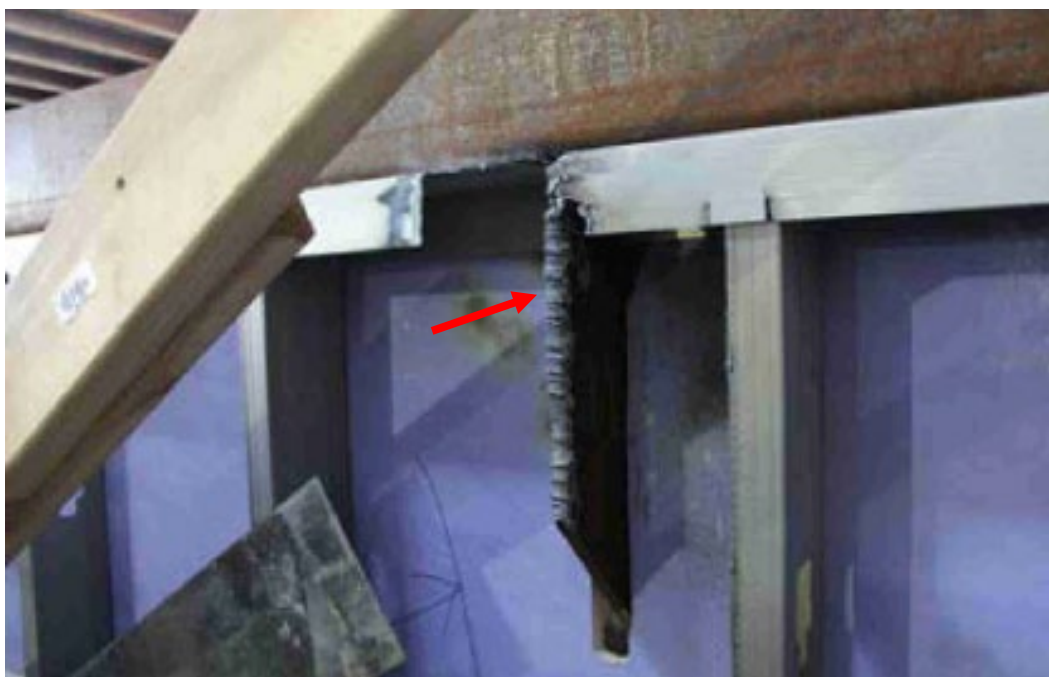
Pursuant to the deficient dimensional control, the bent plates needed adjustment to accommodate the changing building dimensions as discussed above. While the bent plates could be adjusted inward or outward, the knife plates that were prefabricated to specific dimensions could not be moved inward due to interference with the steel beam web and outward movement would likely trigger structural redesign. During a site visit by the architect-of-record (Arch), it was noted that the knife plates extended beyond the metal stud framing and bent plates due to the dimensional control issues. The Arch provided instruction to trim the knife plates so that they were no longer proud of the exterior studs and bent plates. An example of a trimmed knife plate is shown in Figure 3. Though the Arch instructed the knife plates to be trimmed, this was not done consistently across the project, which resulted in knife plates continuously being observed to protrude through exterior sheathing and interior gypsum board as is discussed in more detail below.

**Figure 3. Trimmed knife plate edge (indicated).**

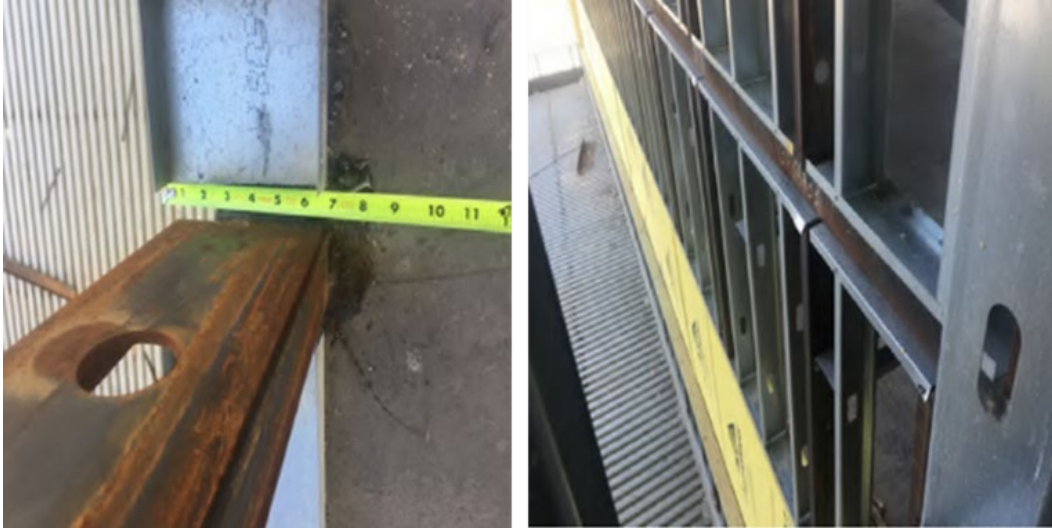
The strategy of moving the stud walls out was later endorsed by the Arch who instructed the DPE Sub to bring out the stud wall framing so that the stud track, knife plates, and bent plates were not proud of it. Figure 5 demonstrates a condition where a stud wall was noticeably overhanging the slab edge.

**Figure 5. Photographs of the stud track (left) and stud wall (right) overhanging the edge-of-slab.**

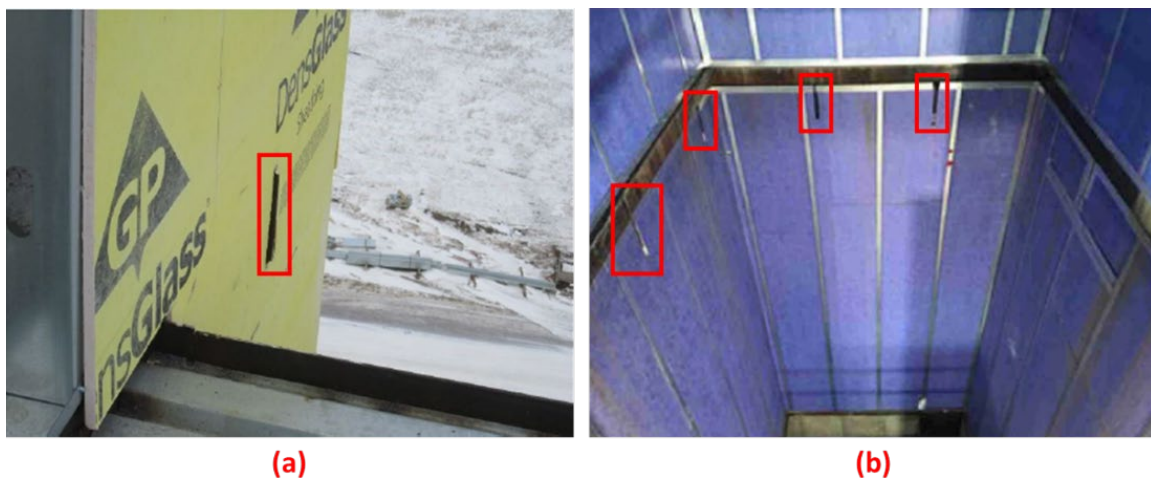
were clad in gypsum board that was specific for shaft wall assemblies. As a result of the deficient dimensional control, the bent plates at the concrete deck edges, the knife-plates, and the metal stud walls required adjustments (see previous discussion). This condition led to the exterior sheathing being out-of-plumb and knife plates protruding through the sheathing on the exterior walls (Figure 6a). The lack of plumbness and protrusions in the exterior sheathing prevented the vapor barrier, exterior insulation, and metal panel façade from being installed correctly, which subjected the interior of the structure to the harsh environment.

At the interior, the dimensional control issues and/or design flaws resulted in the knife plates protruding through shaft wall liners, which impacted the 2-hr fire rating of the walls. In meeting notes between the Owner, Arch, and GC, it was acknowledged that the wall had been designed such that the inside edges of the knife plates were in the same plane as the inside edge of the shaft liner. The proposed fix was supposed to be a UL-rated and approved assembly. The DPE Sub was made aware of the proposed repair and understood that the issue would be addressed by the fireproofing subcontractor (Fire Sub); however, project management did not properly communicate or coordinate between the two trades, and the defect in the 2-hr fire walls was left unaddressed (Figure 6b).

**Figure 6. Photographs demonstrating knife plate penetrating (a) an exterior wall and (b) a 2-hr fire rated elevator shaft wall.**
