## ASCE 10th Forensic Engineering Congress

### Unraveling Project Pitfalls: A Forensic Exploration of Communication, Coordination, and Collaboration Breakdowns in Construction

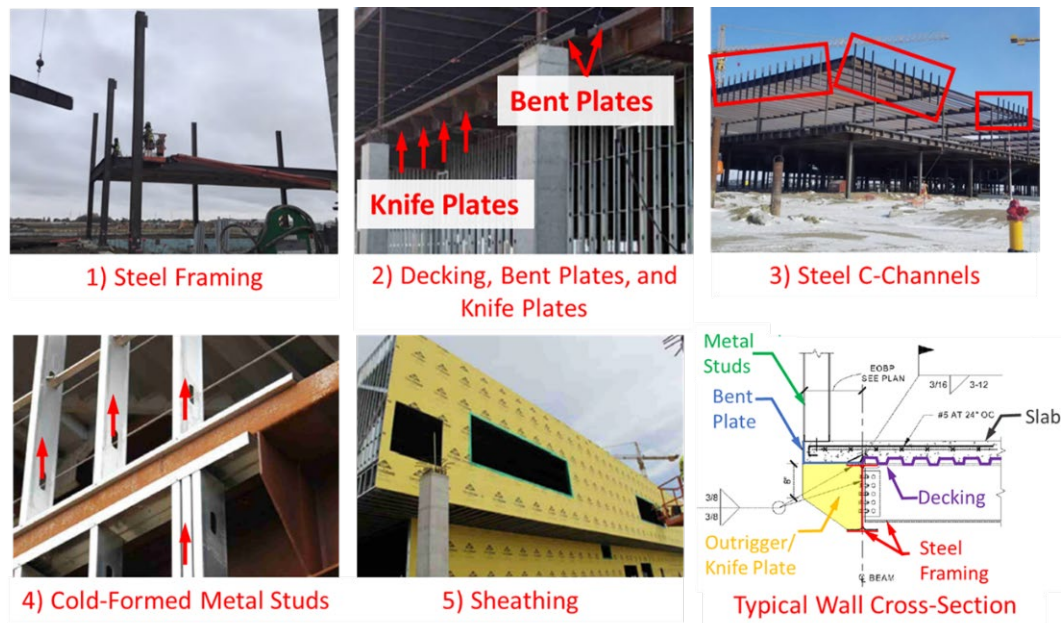
During construction, early issues with dimensional control resulted in the structural steel framing being out of plumb. Considering that building elements such as the deck forming (bent plates and knife plates), steel channels, cold-formed metal stud wall framing, and exterior sheathing were installed after the structural framing, issues with framing plumbness created a series of required adjustments that affected the placement of each of the subsequent elements. Figure 2 outlines the sequence of construction and provides a typical cross-section demonstrating how the various elements were integrated together.

**Figure 2. Construction sequence and exterior wall cross-section.**
